[Docket No. FAA–2015–0497; Directorate Identifier 2012–NM–192–AD; Amendment 39–18128; AD 2015–06–10]

Airworthiness Directives; ATR–GIE Avions de Transport Régional Airplanes

SUMMARY: We are adopting a new airworthiness directive (AD) for certain ATR–GIE Avions de Transport Régional Model ATR72–212A airplanes. This AD requires inspection of the shock mount pick-up fittings and cone bolts, and replacement of certain shock mount pick-up fittings if necessary. This AD was prompted by reports of several cases of engine shock mount pick-up fittings with cracks or failure on the engine left-hand (LH) aft side attachment. We are issuing this AD to detect and correct an aft side attachment

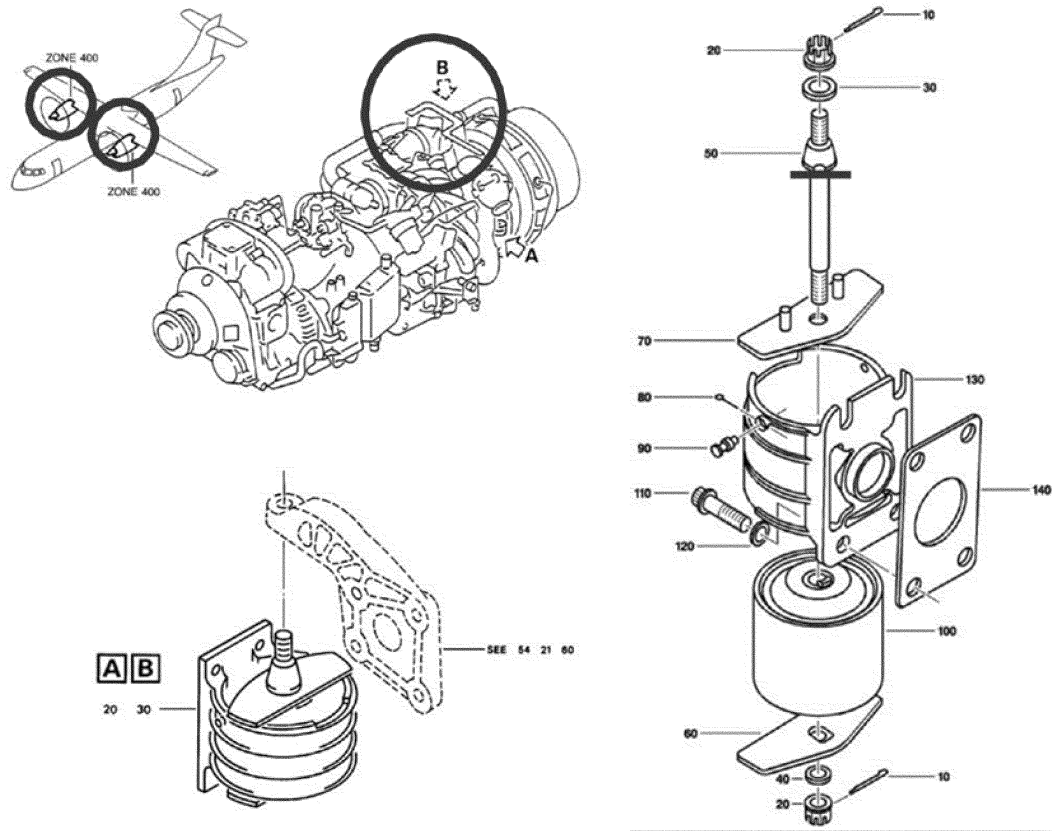
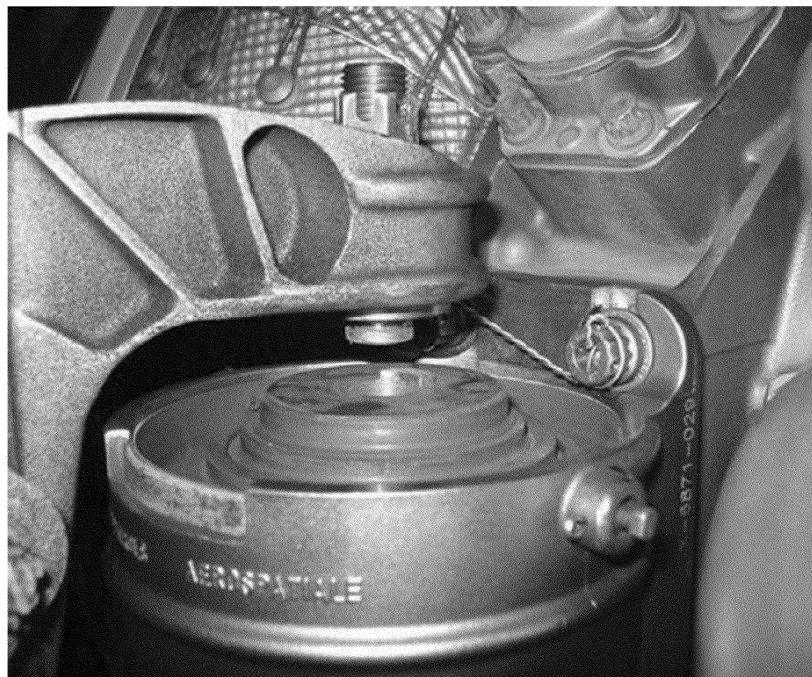
Figure 3 to paragraph (g)(3) of this AD - Shock Mount Cone Bolt

(3) Do a detailed inspection of both LH and RH aft shock mount cone bolts on both engines to detect cracks, in accordance with

paragraph 006.3.A. of ATR ATR72 AMM JIC 71-20-00 DVI 10000. Refer to figure 3 to

paragraph (g)(3) of this AD for potential crack location.

(1) If any crack is found during any inspection required by paragraphs (g)(2) and (g)(3) of this AD: Before further flight, repair in accordance with a method approved by

the Manager, International Branch, ANM-116, Transport Airplane Directorate, FAA; or EASA; or ATR's EASA Design Organization Approval (DOA).
