[Docket No. FAA-2015-1937; Directorate Identifier 2014-SW-067-AD; Amendment 39-18171; AD 2015-11-08]

Airworthiness Directives; Agusta S.p.A. (Agusta) Helicopters

2015–11–08 Agusta S.p.A. Helicopters (Agusta): Docket No. FAA–2015–1937; Amendment 39–18171, Directorate Identifier 2014–SW–067–AD.

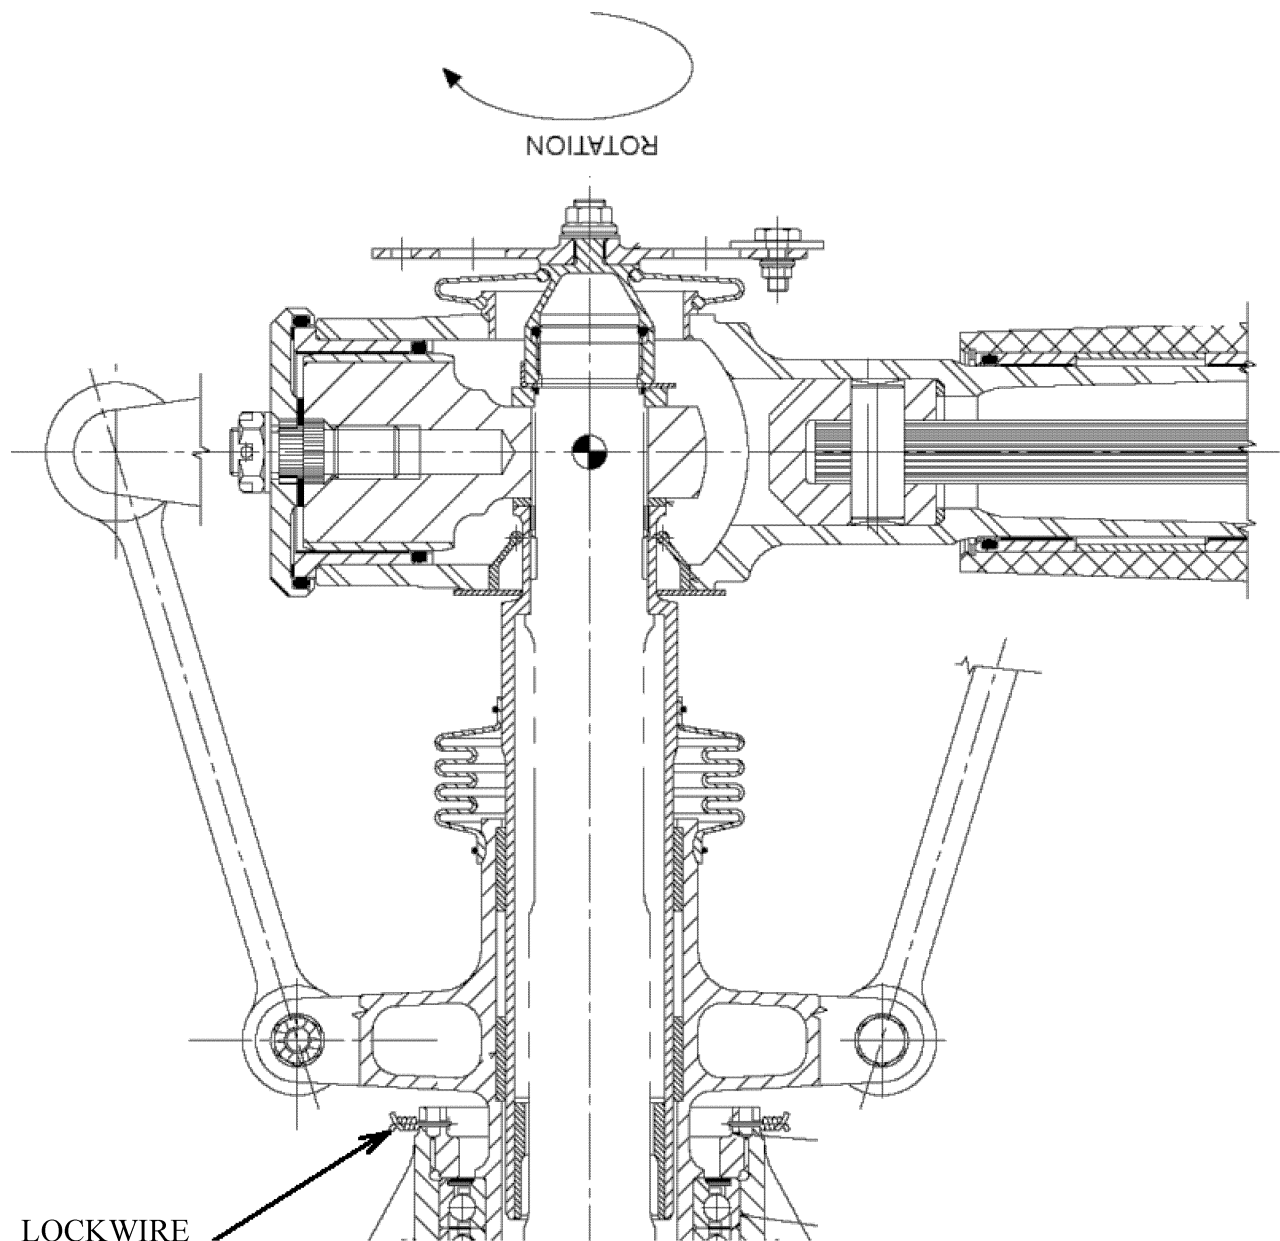
Figure 1 of paragraph (f)(1)

This AD defines the unsafe condition as a missing or broken lock wire securing the tail rotor (T/R) duplex bearing locking nut (locking nut). This condition could result in loosening of the locking nut, failure of the T/R, and subsequent loss of control of the helicopter.

(1) Within 24 hours and thereafter before the first flight of each day or at intervals not exceeding 24 hours, whichever occurs later, check each lock wire securing the T/R locking nut to the housing. The location of the housing wire is depicted in Figure 1 to paragraph (f)(1) of this AD.

(4) If one or both lock wires are missing or damaged, before further flight, remove and reassemble the housing and slider group of the T/R rotating controls.
