DEPARTMENT OF TRANSPORTATION**Federal Aviation Administration****14 CFR Part 39**

[Docket No. FAA–2015–3989; Directorate Identifier 2014–NM–250–AD]

Airworthiness Directives; Airbus Airplanes

ACTION: Notice of proposed rulemaking (NPRM).

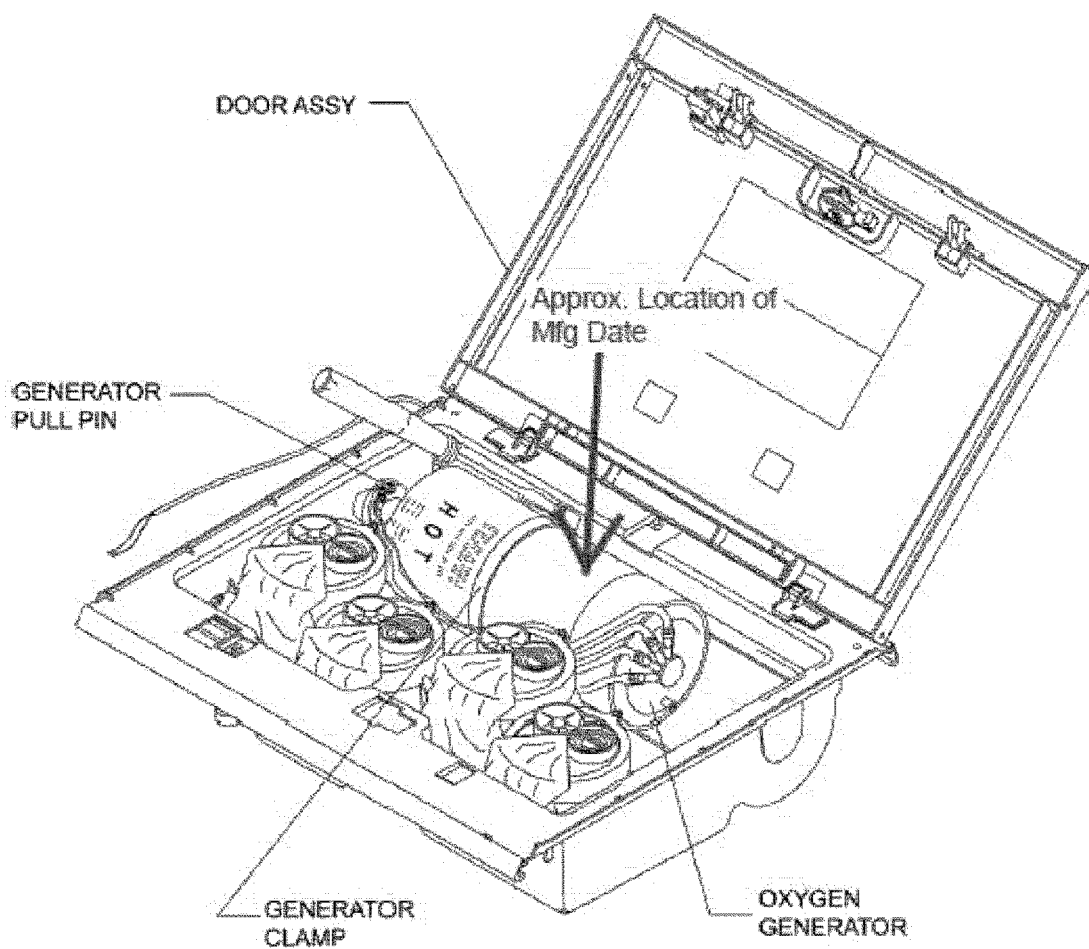
Figure 1 to paragraph (g) of this AD - location of date (MM-YY)

Within 30 days after the effective date of this AD, do a one-time inspection of passenger chemical oxygen generators, part numbers (P/N) 117042-02 (15 minutes (min)-2 masks), 117042-03 (15 min-3 masks), 117042-04 (15 min-4 masks), 117042-22 (22 min-2 masks), 117042-23 (22 min-3 masks), and 117042-24 (22 min-4 masks) to determine the date of manufacture as specified in Airbus Alert Operators Transmission (AOT) A35N006-14, dated December 10, 2014, including Appendix 01. Refer to figure 1 and figure 2 to paragraph (g) of this AD for the location of the date. A review of airplane maintenance records is acceptable for the inspection required by paragraph (g) of this AD, provided the date of manufacture can be conclusively determined by that review.

If, during any inspection required by paragraph (g) of this AD, any passenger chemical oxygen generator having a date of manufacture in 1999, 2000, or 2001 is found: At the applicable time specified in paragraph (h)(1), (h)(2), or (h)(3) of this AD, remove and replace the affected passenger chemical oxygen generator with a serviceable unit, in accordance with the Accomplishment Instructions of B/E Aerospace Service Bulletin 117042-35-001, dated December 10, 2014 (for 15 minute passenger chemical oxygen generators); and Airbus AOT A35N006-14, dated December 10, 2014, including Appendix 01 (for 22 minute passenger chemical oxygen generators).
