[Docket No. FAA-2016-4228; Directorate Identifier 2015-NM-107-AD]

#### Airworthiness Directives; Airbus Airplanes

**SUMMARY:** We propose to supersede Airworthiness Directive (AD) 2014-13-12, for all Airbus Model A318, A319, A320, and A321 series airplanes. AD 2014-13-12 currently requires identifying the part number and serial number of each passenger oxygen container, replacing the oxygen generator manifold of any affected oxygen container with a serviceable manifold, and performing an operational check of the manual mask release, and doing corrective actions if necessary. Since we issued AD 2014-13-12, we have determined that affected containers have not only been marked with company name B/E Aerospace, as was specified, but also, for a brief period, with the former company name DAe Systems. This proposed AD would retain the requirements of AD 2014-13-12, and require replacing the oxygen generator manifold of any affected DAe oxygen container with a serviceable manifold. We are proposing this AD to detect and correct non-serviceable oxygen generator manifolds, which could reduce or block the oxygen supply and result in injury to passengers when oxygen supply is needed.

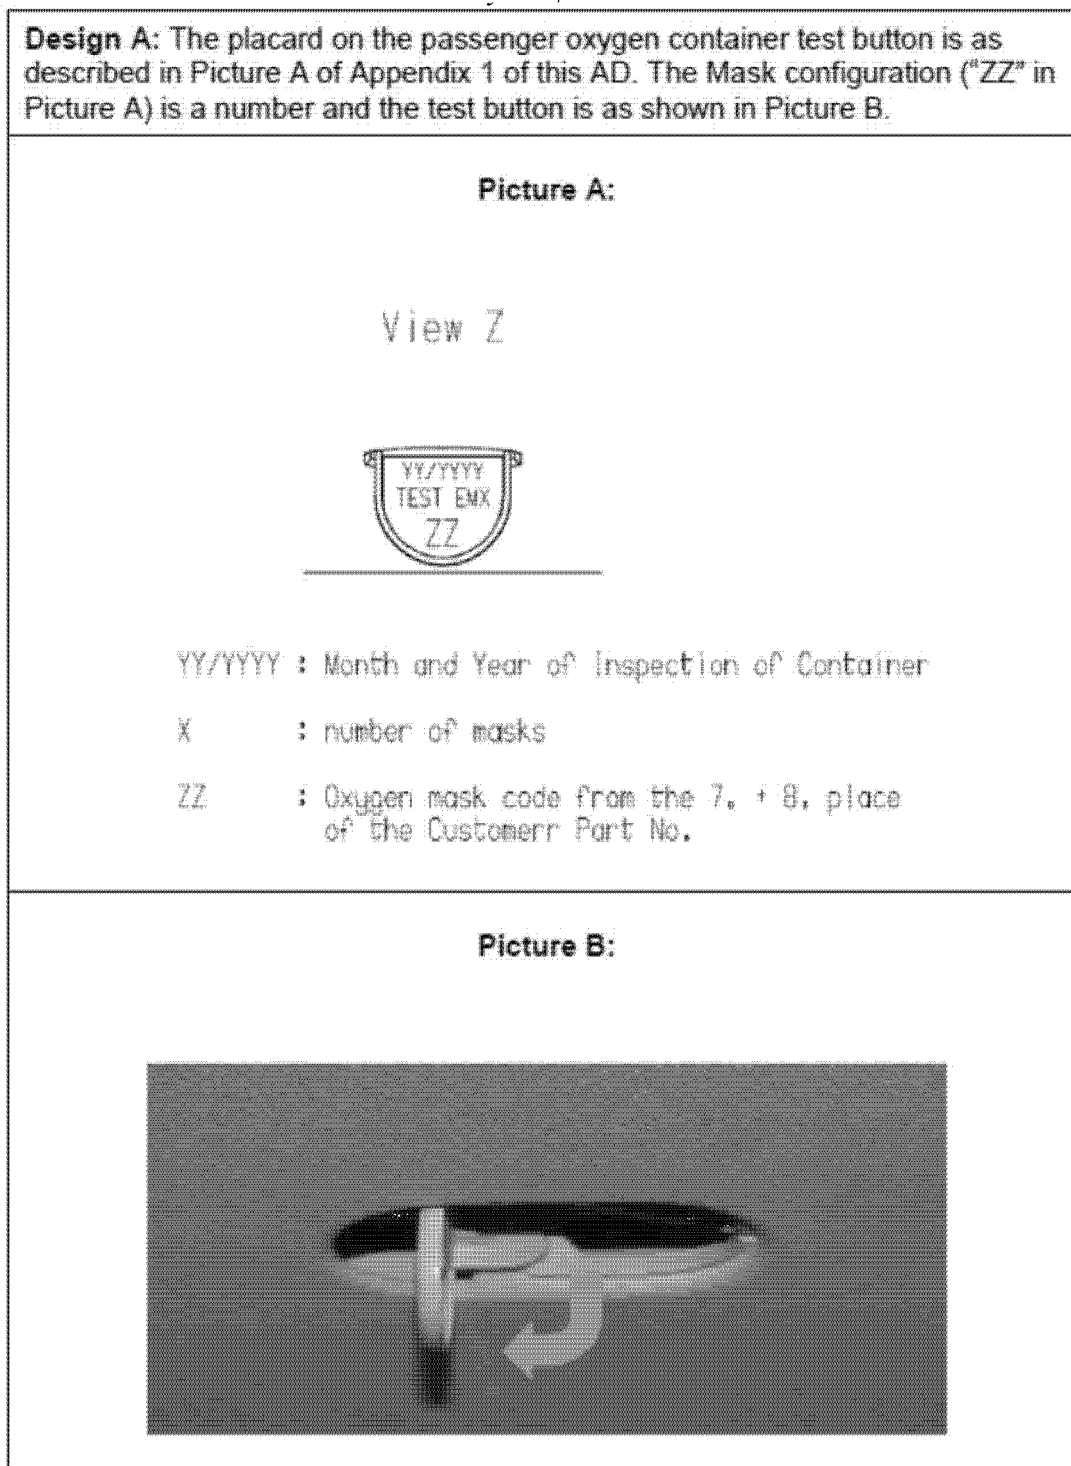
Figure 1 to paragraph (i)(7) of this AD – Design A of the Passenger Oxygen Containers Affected by this AD

(7) The requirements of paragraphs (g) and (h) of this AD apply only to passenger oxygen containers that are Design A, as defined in figure 1 to paragraph (i)(7) of this AD.

**Note 2 to figure 1 to paragraph (i)(7) of this AD:** For “Design A,” the placard on the passenger oxygen container test button is as

described in “Picture A” in figure 1 to paragraph (i)(7) of this AD. The mask configuration (“ZZ” in “Picture A”) is a number, and the test button is as shown in “Picture B.”
