[Docket No. FAA-2015-8463; Directorate Identifier 2014-NM-226-AD]

Airworthiness Directives; Airbus Airplanes

SUMMARY: We propose to supersede Airworthiness Directive (AD) 2013-20-11, for all Airbus Model A318, A319, A320, and A321 series airplanes. AD

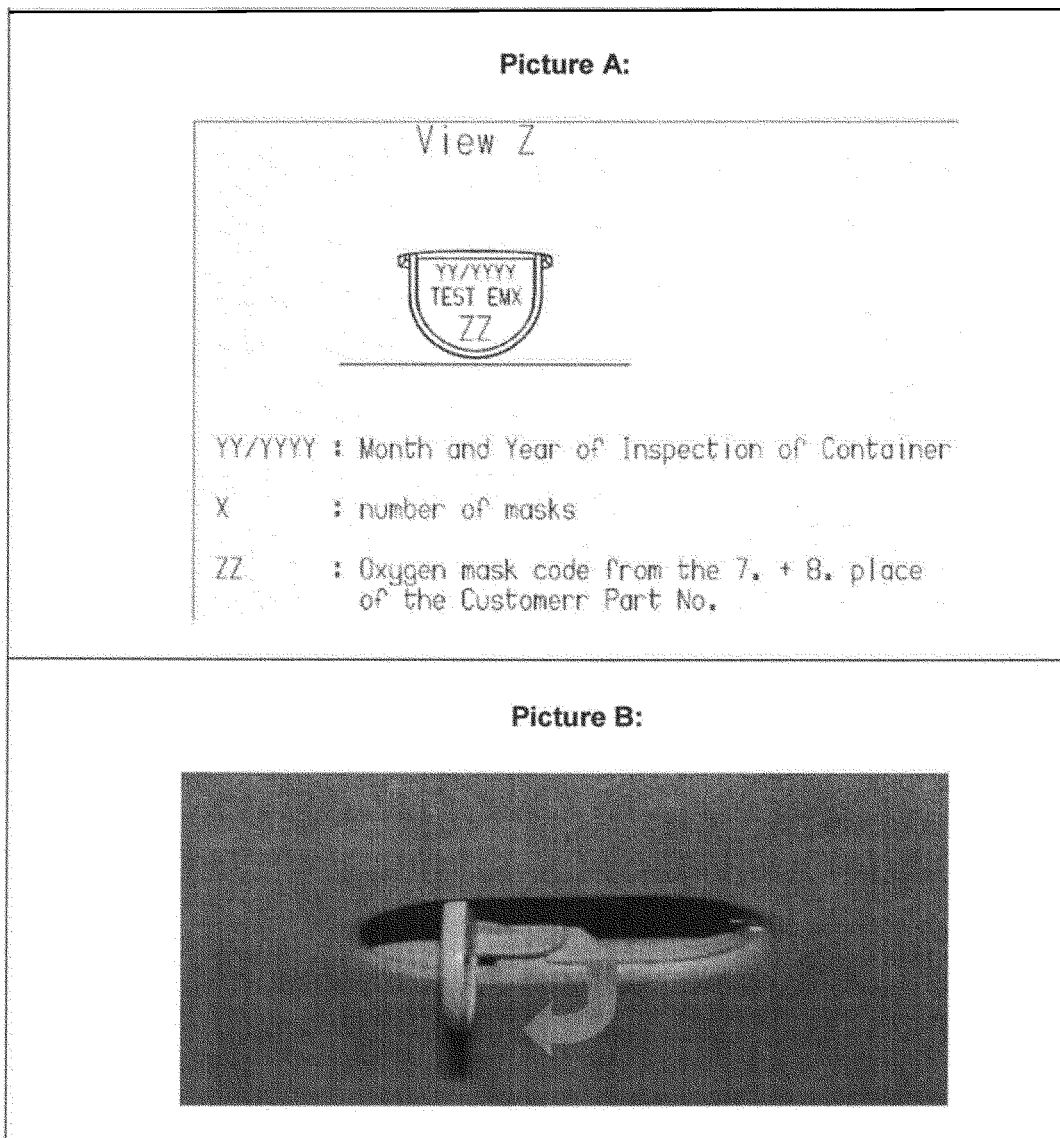
Figure 1 to Paragraph (l)(4) of this AD – Design A of the Passenger Oxygen Containers

Note 2 to paragraph (l)(4) of this AD: For "Design A," the placard on the passenger oxygen container test button is as described in "Picture A" in figure 1 to paragraph (l)(4) of this AD. The mask configuration ("ZZ" in "Picture A") is a number, and the test button is as shown in "Picture B."
