[Docket No. FAA-2015-3989; Directorate Identifier 2014-NM-250-AD; Amendment 39-18600; AD 2016-16-02]

Airworthiness Directives; Airbus Airplanes

2016–16–02 Airbus: Amendment 39–18600. Docket No. FAA–2015–3989; Directorate Identifier 2014–NM–250–AD.

Air Transport Association (ATA) of America Code 35, Oxygen.

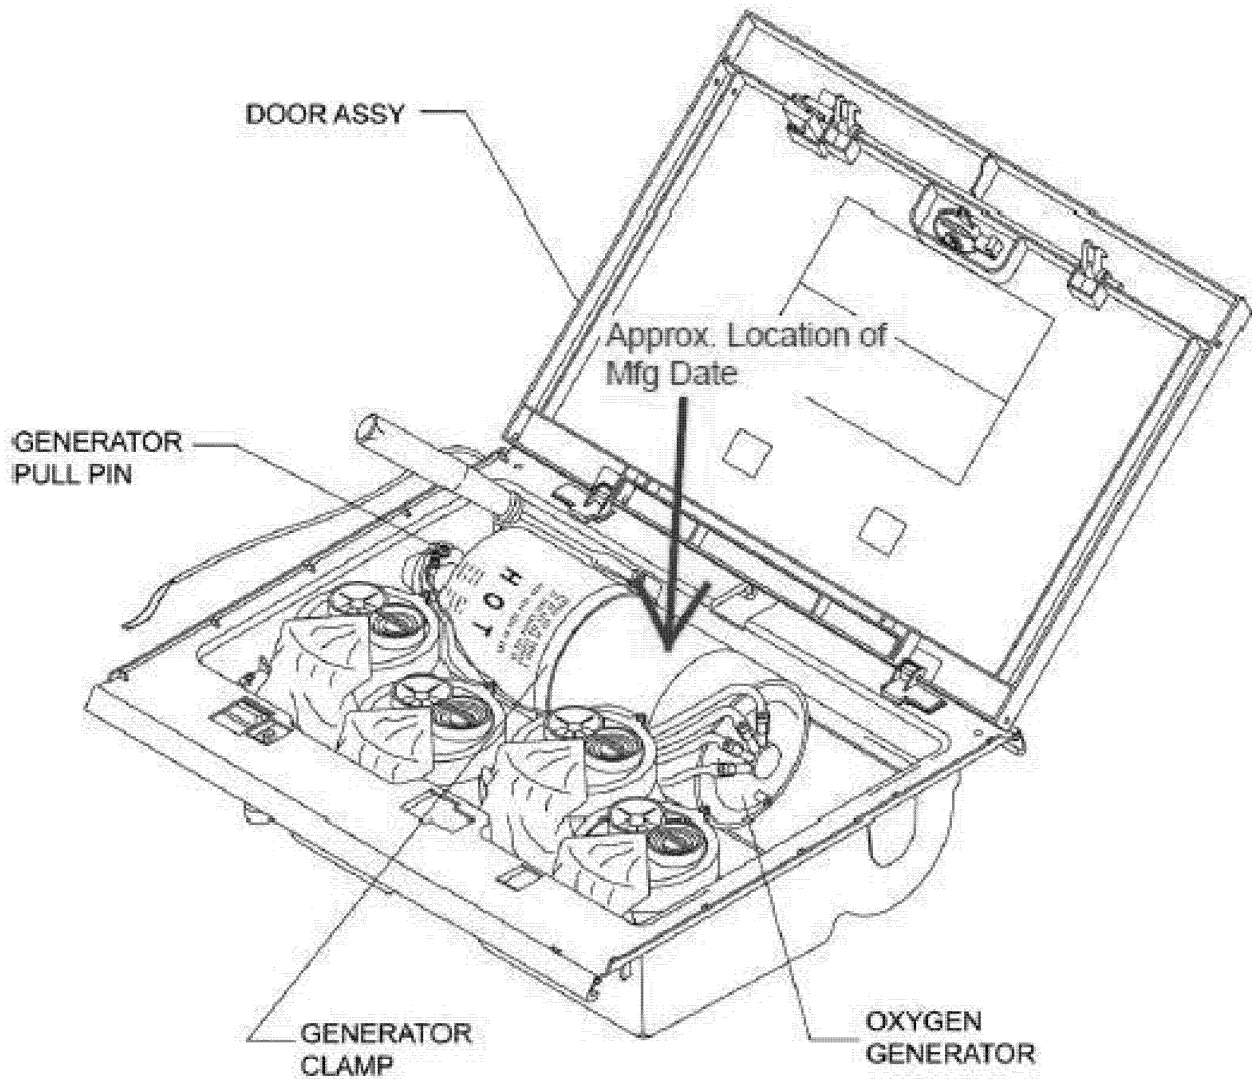
Figure 1 to Paragraph (g) of this AD - Location of Date (MM-YY)

Within 30 days after the effective date of this AD: Do a one-time inspection of passenger chemical oxygen generators, part numbers (P/N) 117042–02 (15 minutes (min)—2 masks), 117042–03 (15 min—3 masks), 117042–04 (15 min—4 masks), 117042–22 (22 min—2 masks), 117042–23 (22 min—3 masks), and 117042–24 (22 min—4 masks) to determine the date of manufacture as specified in Airbus Alert Operators Transmission (AOT) A35N006–14, dated December 10, 2014, including Appendix 1. Refer to figures 1 and 2 to paragraph (g) of this AD for the location of the date. A review of airplane maintenance records is acceptable for the inspection required by this paragraph, provided the date of manufacture can be conclusively determined by that review.
