**[Docket No. FAA-2015-8463; Directorate Identifier 2014-NM-226-AD; Amendment 39-18612; AD 2016-16-14]**

#### **Airworthiness Directives; Airbus Airplanes**

**2016–16–14 Airbus:** Amendment 39–18612; Docket No. FAA–2015–8463; Directorate Identifier 2014–NM–226–AD.

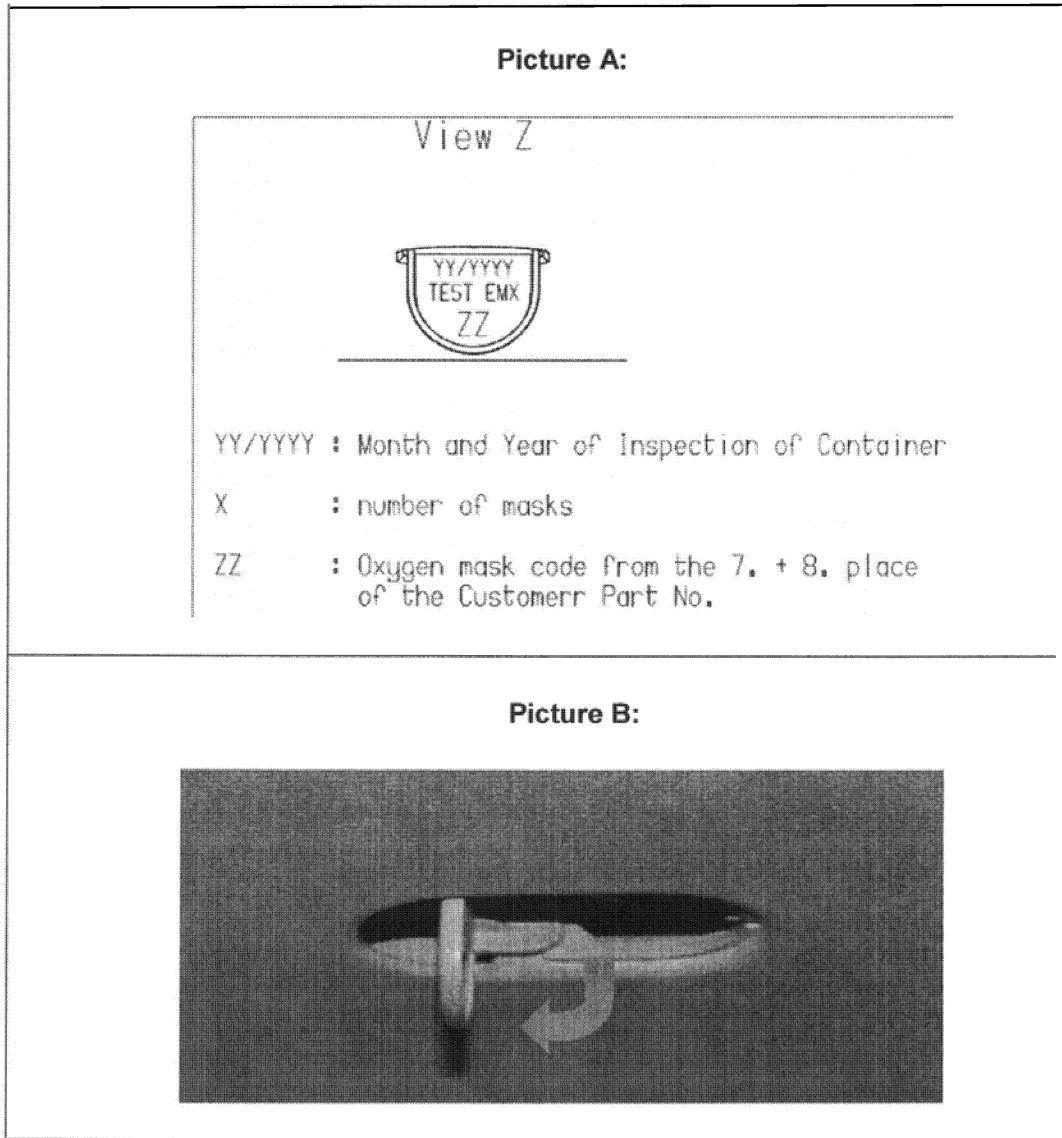
**Figure 1 to Paragraph (l)(4) of this AD – Design A of the Passenger Oxygen Containers**

(4) Airplanes on which the design of the passenger oxygen container is not Design A, as defined in figure 1 to paragraph (l)(4) of this AD, are excluded from the requirements of paragraph (i) of this AD for that passenger oxygen container.

**Note 2 to paragraph (l)(4) of this AD:** For "Design A," the placard on the passenger oxygen container test button is as described in "Picture A" in figure 1 to paragraph (l)(4) of this AD. The mask configuration ("ZZ" in "Picture A") is a number, and the test button is as shown in "Picture B."
