[Docket No. FAA-2015-7527; Directorate Identifier 2015-NM-094-AD; Amendment 39-18686; AD 2016-21-05]

Airworthiness Directives; The Boeing Company Airplanes

2016–21–05 The Boeing Company:
Amendment 39–18686; Docket No. FAA–2015–7527; Directorate Identifier 2015–NM–094–AD.

Air Transport Association (ATA) of America Code 2822, Fuel Boost Pump.

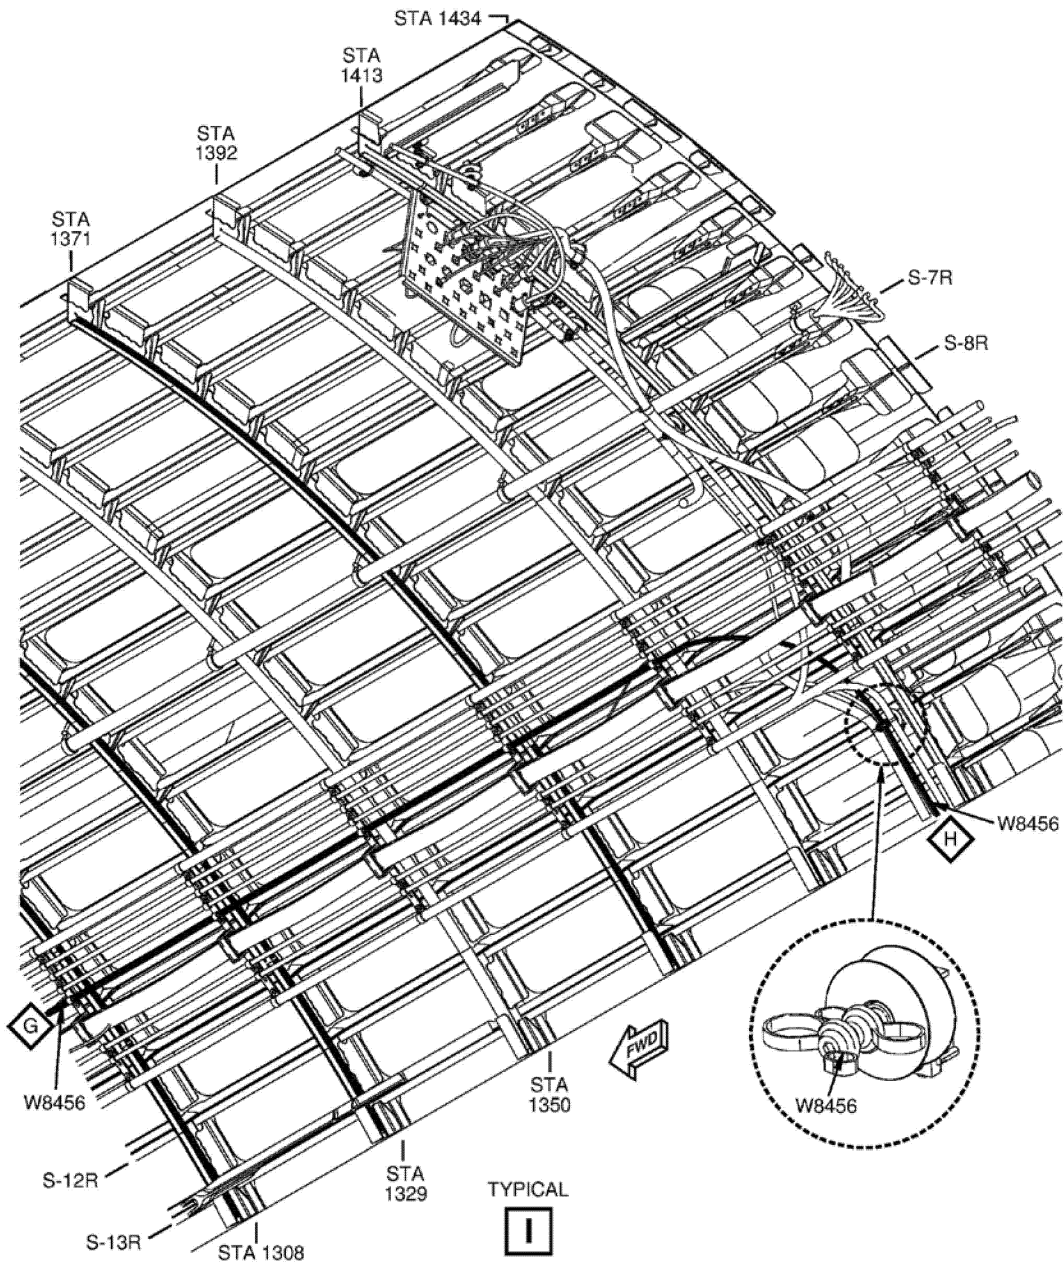
Figure 1 to paragraph (h) of this AD: Wiring Installation - Right Engine Fuel Spar Valve

appropriate source of service information in this AD because it is not an FAA-approved document. However, we acknowledge that for certain airplanes, Figure 22, Sheet 9, of Boeing Special Attention Service Bulletin 777-28-0061, Revision 2, dated May 4, 2015, includes an editorial error, which shows incorrect wire routing. Boeing Service Bulletin Information Notice 777-28-0061, IN 03, dated November 16, 2015, allows for a modification of Group 2 airplanes that meets the requirements of the AD without an additional burden to operators. We have included a corrected figure in paragraph (h) of this AD to address this issue.

(1) Where Boeing Special Attention Service Bulletin 777–28–0061, Revision 2, dated May 4, 2015, specifies to use Figure 22, Sheet 9, for the wiring installation of the right engine fuel spar valve, this AD requires using figure 1 to paragraph (h) of this AD.
