[Docket No. FAA-2016-9418; Directorate Identifier 2016-NE-23-AD]

#### Airworthiness Directives; Honeywell International Inc. Turboprop and Turboshaft Engines

**ACTION:** Notice of proposed rulemaking (NPRM).

**SUMMARY:** We propose to adopt a new airworthiness directive (AD) for certain Honeywell International Inc. (Honeywell) TPE331 turboprop and TSE331 turboshaft engines. This proposed AD was prompted by reports that combustion chamber case assemblies have cracked and ruptured. This proposed AD would require inspection of the affected combustion chamber case assembly, replacement of those assemblies found cracked, and removal of affected assemblies on certain TPE331 engines. We are proposing this AD to correct the unsafe condition on these products.

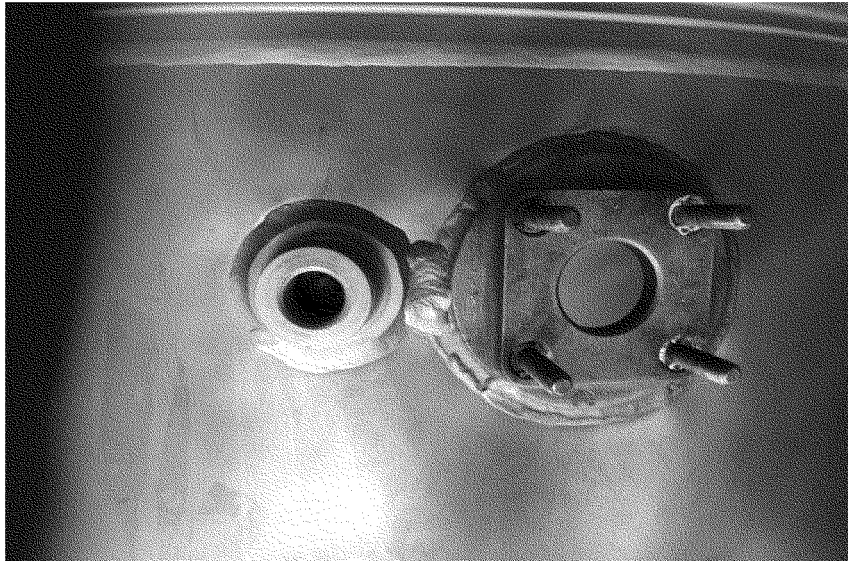
**Figure 1 to Paragraph (g) of this AD. Combustion Chamber Case Assembly  
Without the One-Piece Bleed Pad with P3 Boss**

(2) For TPE331-3U, -3UW, -5, -5A, -5AB, -5B, -6, -6A engines with combustion chamber case assemblies, part numbers (P/Ns) 869728-1, 869728-3, or 893973-5, installed, and without the one-piece bleed pad with P3 boss, and for TPE331-1, -2, and -2UA engines modified with increased P3 pressures, including, but not limited to, engines modified by supplemental type certificate (STC) SE383CH, remove the combustion chamber case assembly from service at the next removal of the combustion chamber case from the engine.

(2) Figures 1 and 2 to paragraph (g) of this AD illustrate the appearance of combustion chamber case assembly, P/N 893973-5, without and with, respectively, the one-piece bleed pad with the P3 boss.

After the effective date of this AD, do not install a combustion chamber case assembly, P/N 869728-1, 869728-3, or 893973-5, in an engine, unless the combustion chamber case assembly has a one-piece bleed pad with P3 boss.
