[Docket No. **FAA-2016-4674**; Directorate Identifier **2016-SW-001-AD**; Amendment **39-18835**; AD **2017-06-11**]

#### **Airworthiness Directives; Airbus Helicopters**

**2017-06-11 Airbus Helicopters:**  
Amendment 39-18835; Docket No. FAA-2016-4674; Directorate Identifier 2016-SW-001-AD.

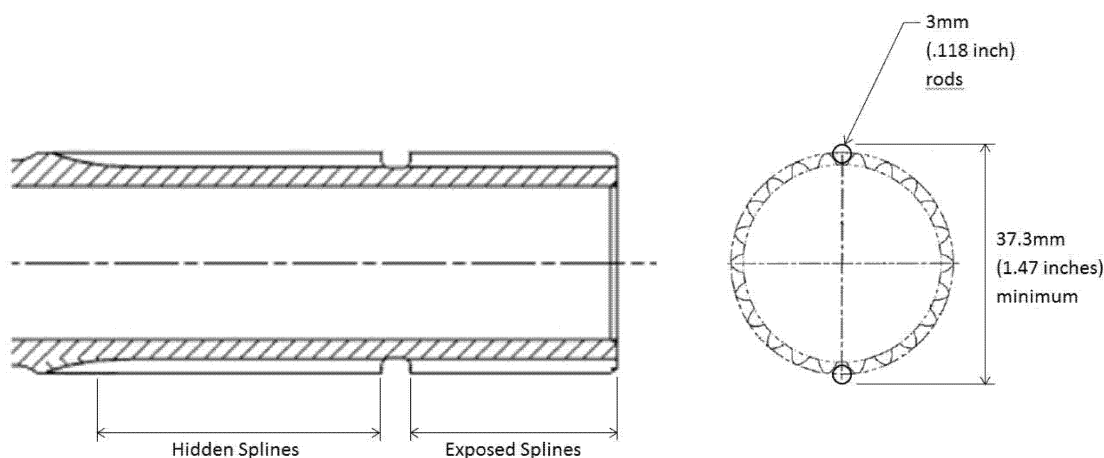
(ii) Inspect the exposed portion of each wheel spline for cracking, scoring, metal pick-up, and wear by using Figure 1 to paragraph (f)(1)(ii) of this AD. To inspect for wear, position two 3 mm (0.118 inch) rods in all diametrically opposed splines and measure to determine whether there is a minimum of 37.3 mm (1.47 inches) across the outside diameter of the rods. If there is any cracking, scoring or metal pick-up, or if a measurement is less than 37.3 mm, replace the wheel.
