[Docket No. FAA-2016-9254; Directorate Identifier 2015-CE-030-AD; Amendment 39-18948; AD 2017-14-04]

#### Airworthiness Directives; Piper Aircraft, Inc. Airplanes

**2017–14–04 Piper Aircraft, Inc.:**  
Amendment 39–18948; Docket No. FAA–2016–9254; Directorate Identifier 2015–CE–030–AD.

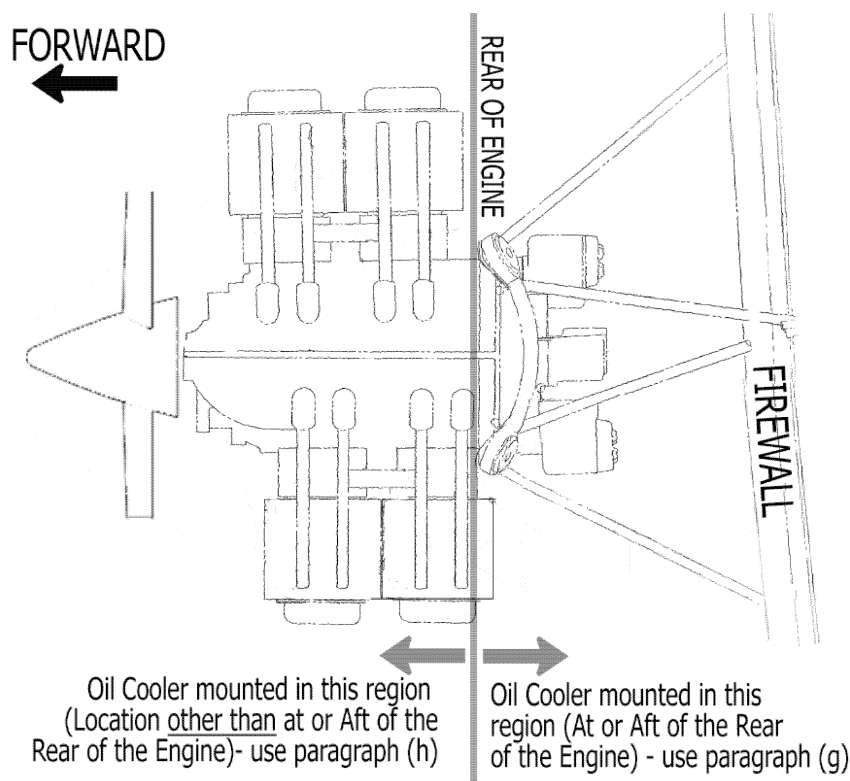
Figure 1 to paragraphs (g) and (h) of this AD: Oil cooler

*For any oil cooler hose assemblies that do not meet TSO–C53a, Type D requirements:* Within the next 100 hours time-in-service (TIS) after February 5, 1996 (the effective date retained from AD 95–26–13), and repetitively thereafter at intervals not to exceed 100 hours TIS, inspect the fire sleeve of each oil cooler hose assembly for soaked oil, a brownish or whitish color, and any evidence of brittleness or deterioration as a result of heat or oil seepage. See figure 1 to paragraphs (g) and (h) of this AD for additional information.

after February 5, 1996 (the effective date retained from AD 95-26-13), and repetitively thereafter at intervals not to exceed 100 hours TIS, inspect the fire sleeve of each oil cooler hose assembly for soaked oil, a brownish or whitish color, and any evidence of brittleness or deterioration as a result of heat or oil seepage. See figure 1 to paragraphs (g) and (h) of this AD for additional information.

(1) If any of the conditions described in paragraph (g) or (h)(1) of this AD are found on an oil cooler hose assembly during the inspection required in paragraph (g) or (h)(1) of this AD, as applicable, before further flight, replace the oil cooler hose assembly with a serviceable new or used TSO-C53a Type D oil cooler hose assembly or TSO-C53a Type C oil cooler hose assembly. If a used TSO-C53a Type C oil cooler hose assembly is installed, it must have documented hours TIS.

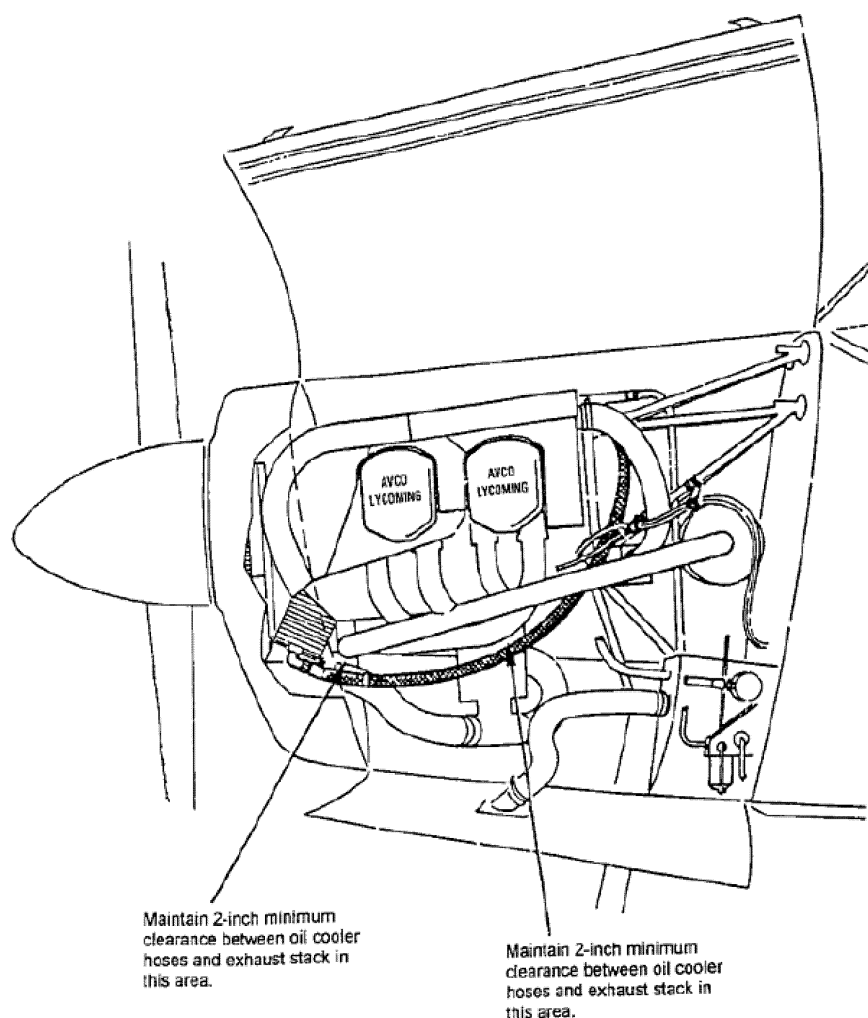
Figure 2 to paragraph (h)(2) of this AD: Acceptable clearances

(2) *For any oil cooler hose assemblies that do not meet TSO-C53a, Type D requirements:* Within the next 100 hours TIS after February 5, 1996 (the effective date retained from AD 95-26-13) and repetitively thereafter at intervals not to exceed 100 hours TIS, inspect the oil cooler hose assemblies to ensure the installation conditions in paragraphs (h)(2)(i) through (iii) of this AD are met. See figure 1 to paragraphs (g) and

(h) of this AD for additional information. If the conditions listed in paragraphs (h)(2)(i) through (iii) of this AD are not met, before further flight, make any necessary adjustments. See figure 2 to paragraph (h)(2) of this AD for additional information.

(i) The oil cooler hose assemblies pass underneath and behind the electrical ground cable and in front of the lower of the two engine mounts.

(ii) The oil cooler hose assemblies are secured to the engine mount strut and a clearance of at least 2 inches exists between the oil cooler hose assemblies and the exhaust stack.

(iii) Oil cooler hose assemblies with a minimum outer diameter of 0.75 inch are installed with a bend radius of at least 6.5 inches.
