Figure 1 to paragraphs (k)(1)(iii) and (v) of this AD: Cross section of v-band coupling

[Docket No. FAA-2017-0902; Product Identifier 2016-NM-188-AD; Amendment 39-19224; AD 2018-06-04]

Airworthiness Directives; Airbus Airplanes

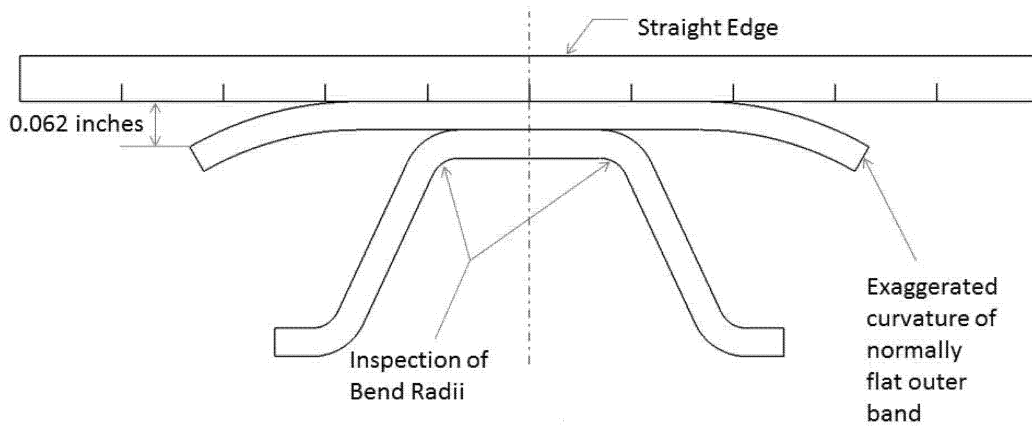
(v) Visually inspect the bend radii of the coupling v-retainer coupling segments for cracks. Inspect the radii throughout the length of the segment. See figure 1 to paragraphs (k)(1)(iii) and (v) of this AD. If any cracks are found, do not re-install the v-band coupling. Before further flight, you must install a new v-band coupling and restart the hours TIS for the repetitive replacement of the v-band coupling.
