[Docket No. FAA-2012-0716; Directorate Identifier 2012-SW-011-AD; Amendment 39-17121; AD 2012-14-07]

#### Airworthiness Directives; Bell Helicopter Textron Canada Helicopters

##### 2012-14-07 Bell Helicopter Textron

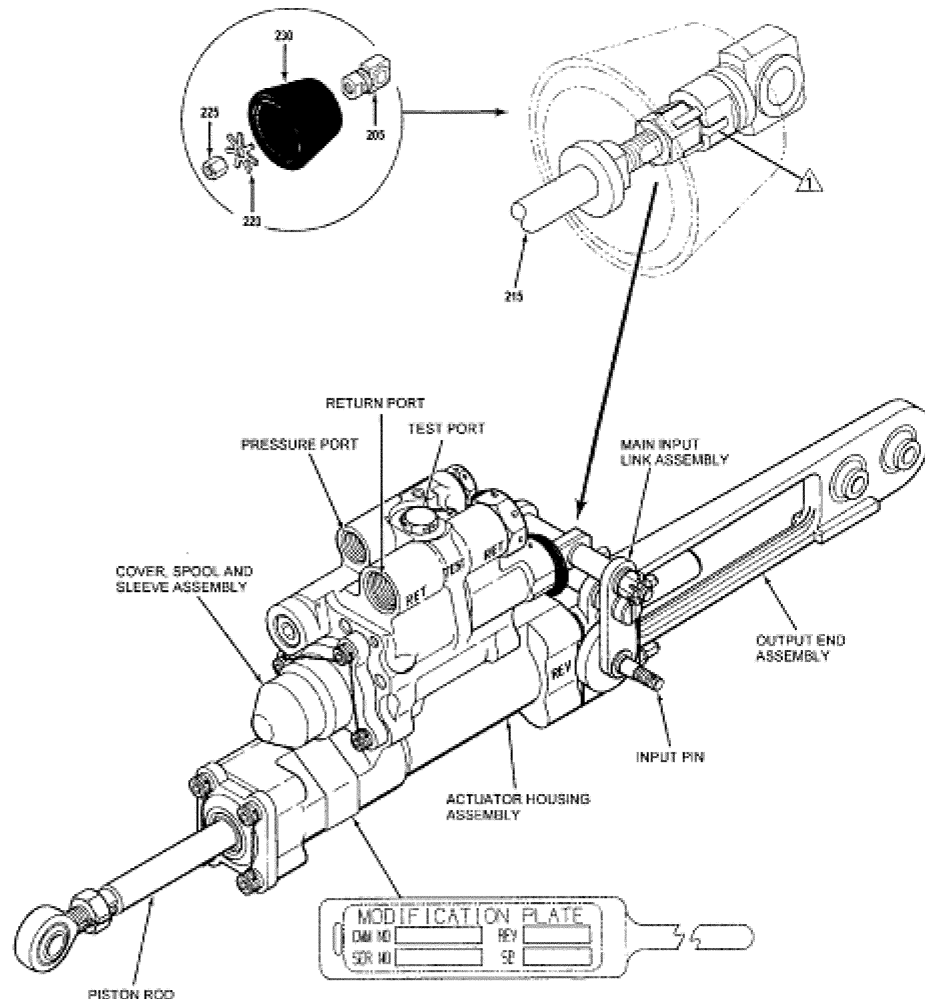
This AD defines the unsafe condition as a loose or misaligned part in the servo that

could lead to failure of the servo and subsequent loss of helicopter control.

**ACCEPTABLE CONDITION**  
A MINIMUM OF ONE TAB SHALL BE IN LINE AND BENT FLUSH WITH THE NUT FLAT SURFACE AND A MINIMUM OF ONE TAB SHALL BE IN LINE AND BENT FLUSH WITH THE CLEVIS ASSEMBLY FLAT SURFACE

(ii) Applying only hand pressure, determine whether the nut, the shaft, or the clevis assembly, depicted as items 225, 215 and 205, respectively, in Figure 1 to Paragraph (f) of this AD, turn independently.

(iii) If the shaft does not turn independently, inspect to determine if at

least one tab of the lock washer is bent flush against a flat surface of the nut and if at least one tab of the lock washer is bent flush against a flat surface of the clevis assembly.

If the shaft turns independently of the nut or clevis assembly, before further flight, replace the servo with an airworthy servo.

(iv) If at least one lock washer tab is not aligned and bent flush with a nut flat surface and at least one lock washer tab is not aligned and bent flush with a flat surface of the clevis assembly, before further flight, replace the servo with an airworthy servo.

(v) If any tab of the lock washer is not bent flush against either a flat surface of the nut or clevis assembly, bend the tab flush against a flat surface.

(2) After accomplishing paragraphs (f)(1)(i) through (f)(1)(v), vibro-etch the letter "V" at the end of the part number on the data plate.
