#### DEPARTMENT OF TRANSPORTATION

#### Federal Aviation Administration

[Docket No. **FAA-2025-2546**; Project Identifier **AD-2025-01060-T**; Amendment **39-23414**; AD 2026-15-02]

#### Airworthiness Directives; The Boeing Company Airplanes

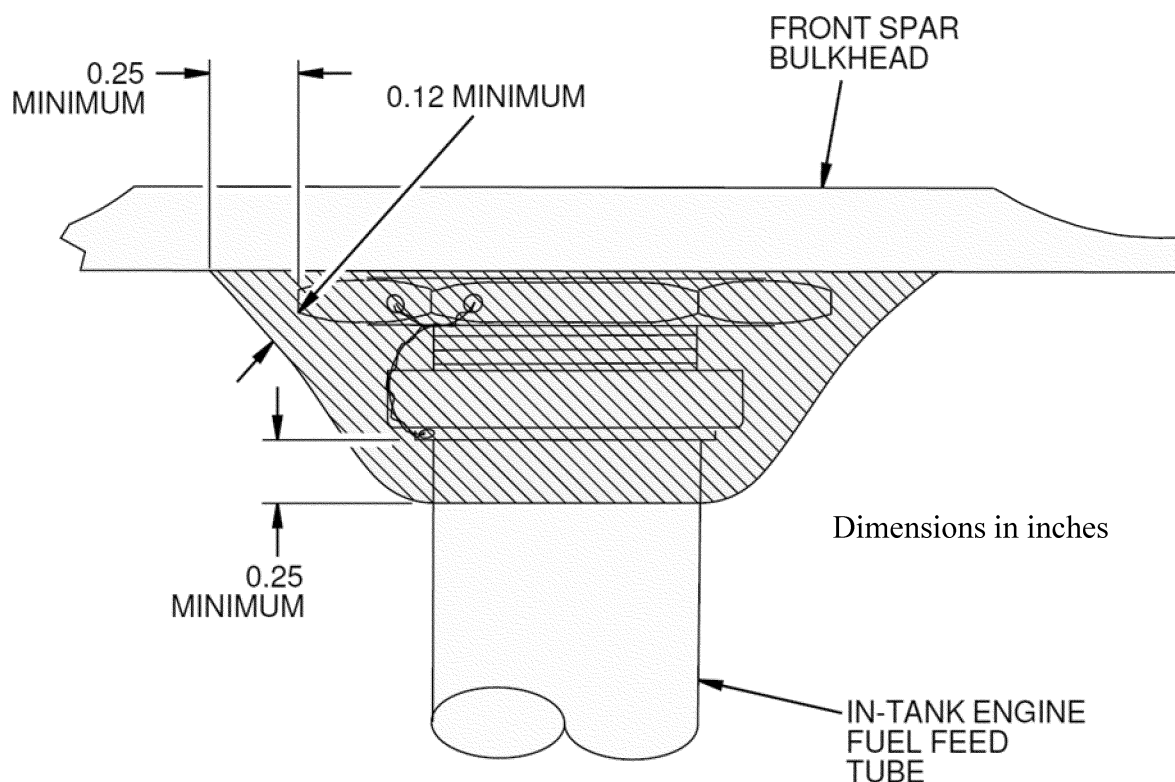
**Figure 2 to paragraph (i) – Fuel Feed Encapsulation**

| <p>ii. A bonding jumper is installed between the second AFT fuel tube and structure inside the tank.</p> <p>1. If the tube-to-structure bonding jumper was removed and reinstalled or replaced, the electrical bonding resistance between the structure and the second AFT fuel tube inside the tank is 0.0100 ohm (10.0 milliohms) or less.</p> <p>4. A full-bodied fillet seal is installed that encapsulates the bulkhead fitting to the front spar and the coupling nut inside the tank. (Refer to Boeing AMM 28-22-15/201 Temporary Revision published between September 16, 2025, and September 17, 2025; Boeing AMM 28-22-15/201 published on or after January 5, 2026.)</p> <p>a. The sealant is smooth and the sealant meets the required dimensions as specified in the accompanying figure.</p> <p>i. Sealant is considered sufficiently thick when the outline of the coupling or fitting hardware is not visible under the sealant.</p> <p>b. Each sealant interface passes an adhesion test using a Fixion eraser.</p> <p>i. Peeling of the brushcoat is not considered a failure if the peeling stops before the Class B seal.</p> | | | | |
