**Airworthiness Directives; MD Helicopters, LLC Helicopters**

**ACTION:** Final rule; correction.

**2026-19-01 MD Helicopters, LLC:**  
Amendment 39-23466; Docket No. FAA-2025-3987; Project Identifier AD-2025-00017-R.

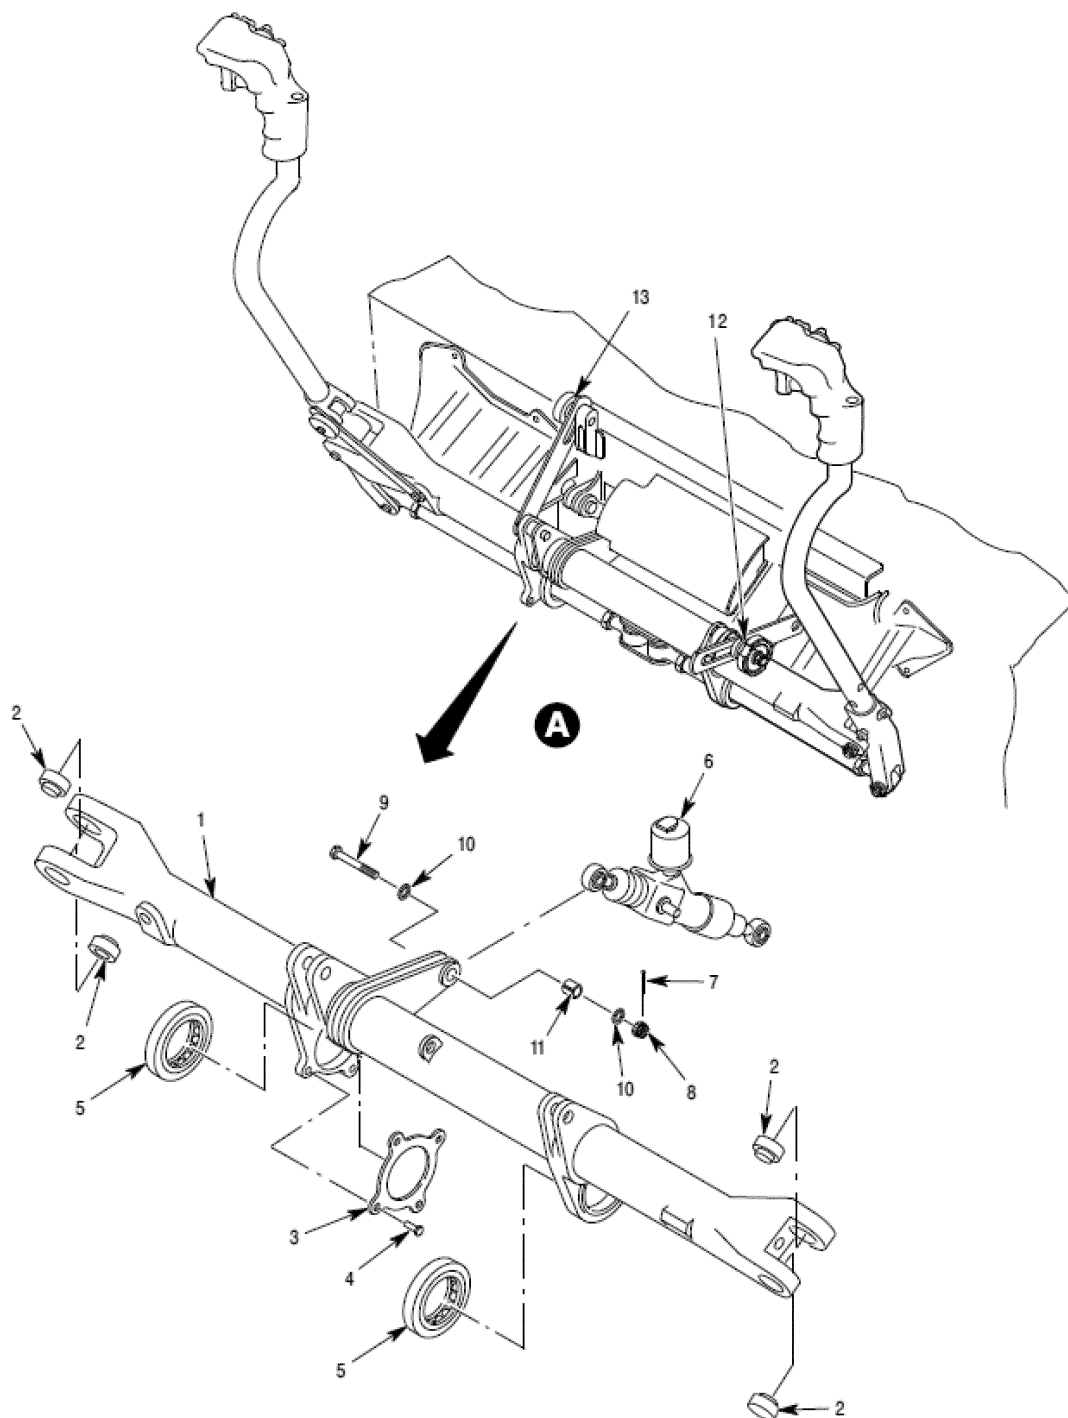
This AD was prompted by a report of a seized and damaged roller bearing assembly in the torque tube assembly. The FAA is issuing this AD to prevent failure of the torque tube assembly. The unsafe condition, if not addressed, could result in reduced controllability and loss of control of the helicopter.

(ii) Visually inspect each roller bearing (number 5) as depicted in Figure 1 to paragraph (g)(1) of this AD for corrosion and degradation. If a roller bearing has any

(A) If there is any binding or ratcheting as a result of the action required by paragraph (g)(2)(iii) of this AD, before further flight, inspect each roller bearing (number 5) as depicted in Figure 1 to paragraph (g)(1) of this AD for damage. For the purposes of this inspection, damage may be indicated by corrosion, lack of lubrication (dry exterior surface), or material degradation.

(B) Ensure the edge of the slotted bushing (number 11) protrudes 0.010 to 0.080 inch (0.25 to 2.03 millimeters) above the surface of the cyclic torque tube after the nut is tightened.

corrosion or degradation, before further flight, remove the roller bearing from service and install an airworthy roller bearing.

(B) If any roller bearing (number 5) as depicted in Figure 1 to paragraph (g)(1) of this AD has any damage, before further flight, remove the roller bearing from service and install an airworthy roller bearing.

(A) Install the slotted bushing (number 11), washers (number 10), bolt (number 9), nut (number 8), and new (zero total hours TIS) cotter pin (number 7) as depicted in Figure 1 to paragraph (g)(1) of this AD.
