[Docket No. FAA-2026-2712; Project Identifier AD-2025-00931-T; Amendment 39-23483; AD 2026-20-10]

#### Airworthiness Directives; The Boeing Company Airplanes

**ACTION:** Final rule.

2026–20–10 The Boeing Company:  
Amendment 39–23483; Docket No. FAA–2026–2712; Project Identifier AD–2025–00931–T.

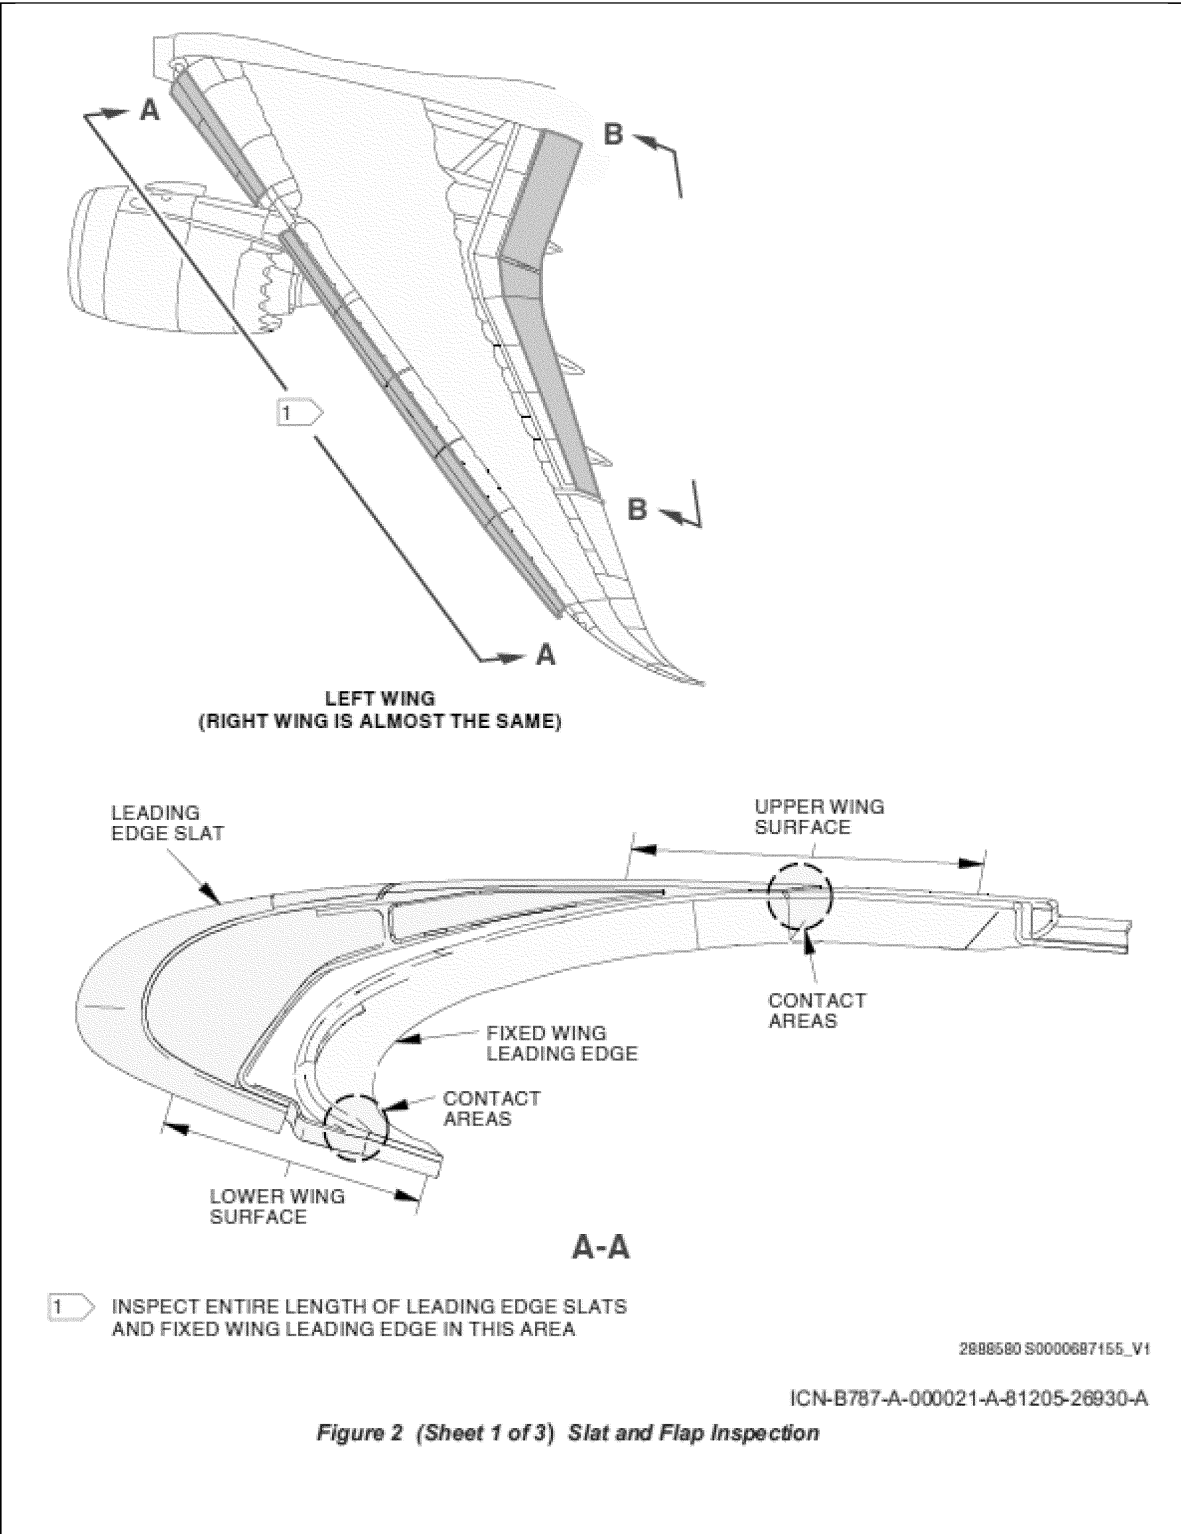
Figure 2 (Sheet 1 of 3) Slat and Flap Inspection

After any landing in icing conditions, do this inspection with the slats/flaps (flaps 25 detent) fully extended (Figure 2):

- (a) Examine these areas for contaminants (ice, snow, slush):

- 1) Slats/flaps surfaces  
2) Leading edge contact surfaces

- 3) Slat actuation areas, including exposed areas of the slat track cavity, and slat cove  
4) Flap tracks, hinges, seals

- (b) Remove the contamination that you find.
