**DEPARTMENT OF TRANSPORTATION**

**National Highway Traffic Safety  
Administration**

**Denial of Motor Vehicle Defect Petition**

**Appendix—Petition Analysis—DP15–005**

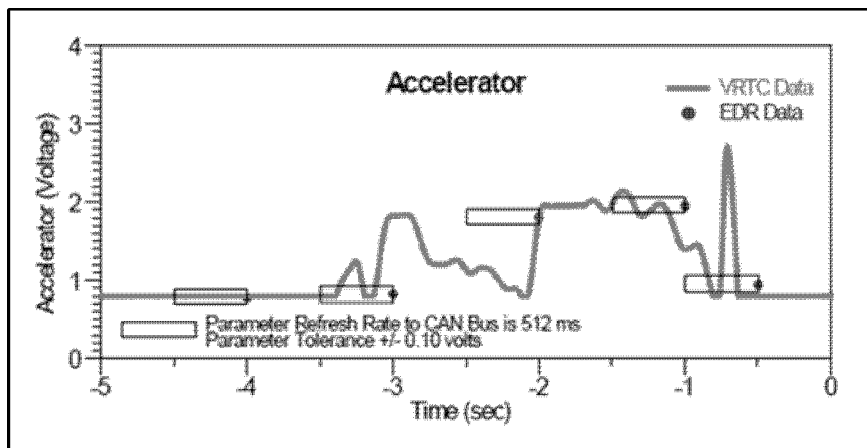
accelerator pedal sensor voltage data from one test performed by VRTC in the validation testing.<sup>5</sup> As the figure shows, the EDR does not necessarily capture all accelerator pedal applications during an event and the accelerator pedal voltage recorded at each EDR time interval may not be the actual accelerator pedal voltage at that interval.

**Figure 1. VRTC validation testing of EDR accelerator pedal sensor voltage from simulated collisions in a 2007 Toyota Camry.**
