[Docket No. FAA-2018-0454; Product Identifier 2017-NM-056-AD; Amendment 39-19387; AD 2018-18-08]

Airworthiness Directives; Airbus SAS Airplanes

2018-18-08 Airbus SAS: Amendment 39-19387; Docket No. FAA-2018-0454; Product Identifier 2017-NM-056-AD.

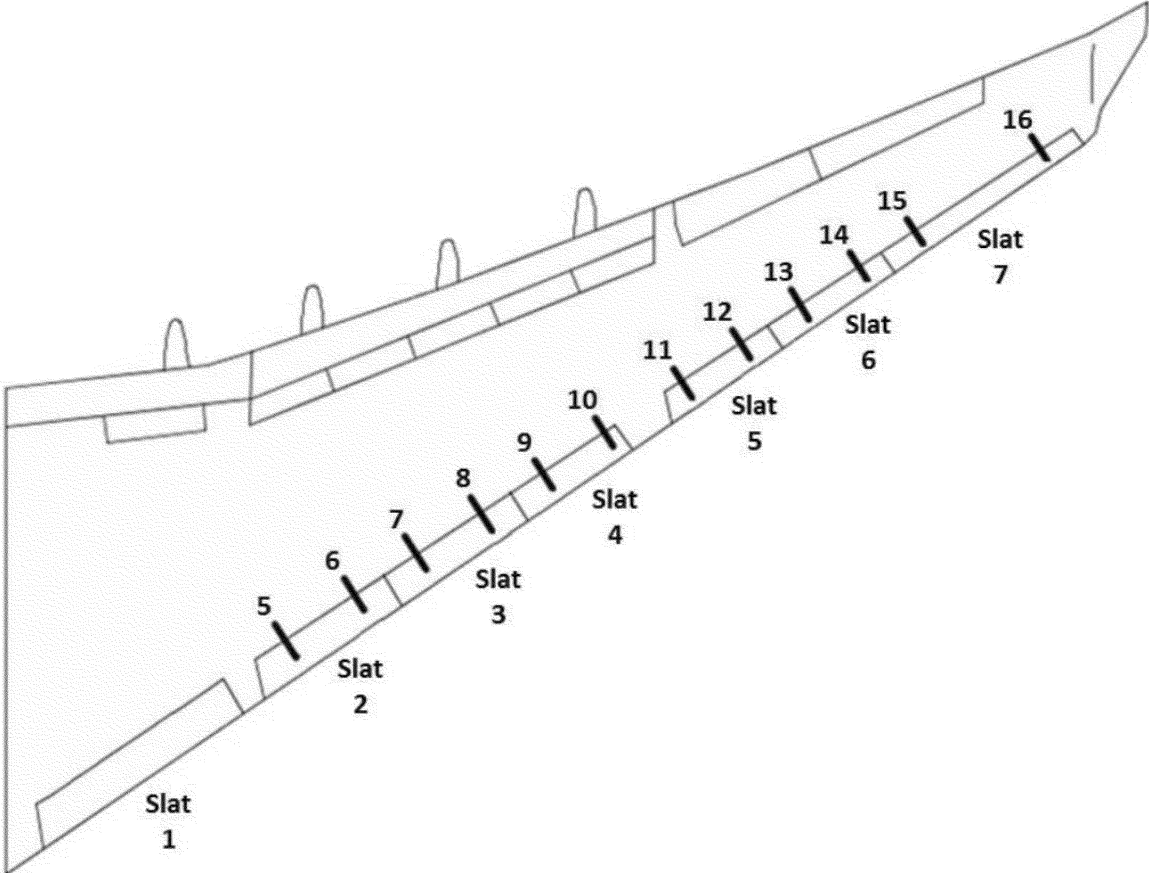
Figure 1 to paragraph (g) of this AD – Positions of Affected Slat Tracks

(1) For the purpose of this AD, "affected slat track" is defined as a pre-modification 45967 slat track, located at the wing positions as indicated in figure 1 to paragraph (g) of this AD, and having a part number specified in figure 2 to paragraph (g) of this AD. In case the part number identification (ID) plate is missing or cannot be read, the slat track can be identified by the ink marking. If the operator cannot determine the part number, then that airplane is in Group 1.
