[Docket No. FAA–2018–0479; Product Identifier 2016–NE–23–AD; Amendment 39–19369; AD 2018–17–15]

### Airworthiness Directives; Honeywell International Inc. Turboprop and Turboshaft Engines

**2018–17–15 Honeywell International Inc. (Type Certificate previously held by AlliedSignal Inc., Garrett Engine Division; Garrett Turbine Engine Company; and AiResearch Manufacturing Company of Arizona):** Amendment 39–19369; Docket No. FAA–2018–0479; Product Identifier 2016–NE–23–AD.

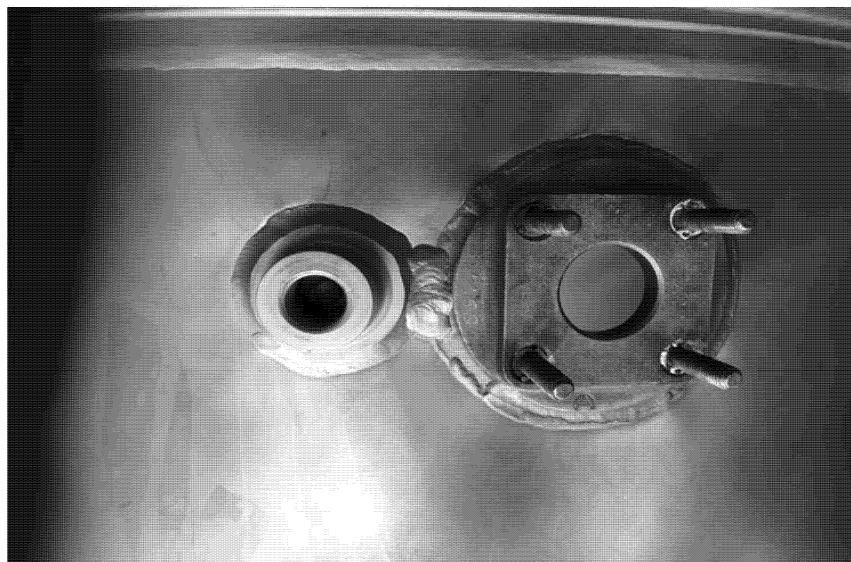
**Figure 1 to Paragraph (h) of this AD. Combustion Chamber Case Assembly Without the One-Piece Bleed Pad with P3 Boss**

(2) Figures 1 and 2 to paragraph (h) of this AD illustrate the appearance of combustion chamber case assembly, P/N 893973–5, without and with, respectively, the one-piece bleed pad with the P3 boss.
