National Highway Traffic Safety Administration

[Docket No. NHTSA–2018–0020]

Denial of Motor Vehicle Defect Petition, DP13–001

ACTION: Denial of petition for a defect investigation.

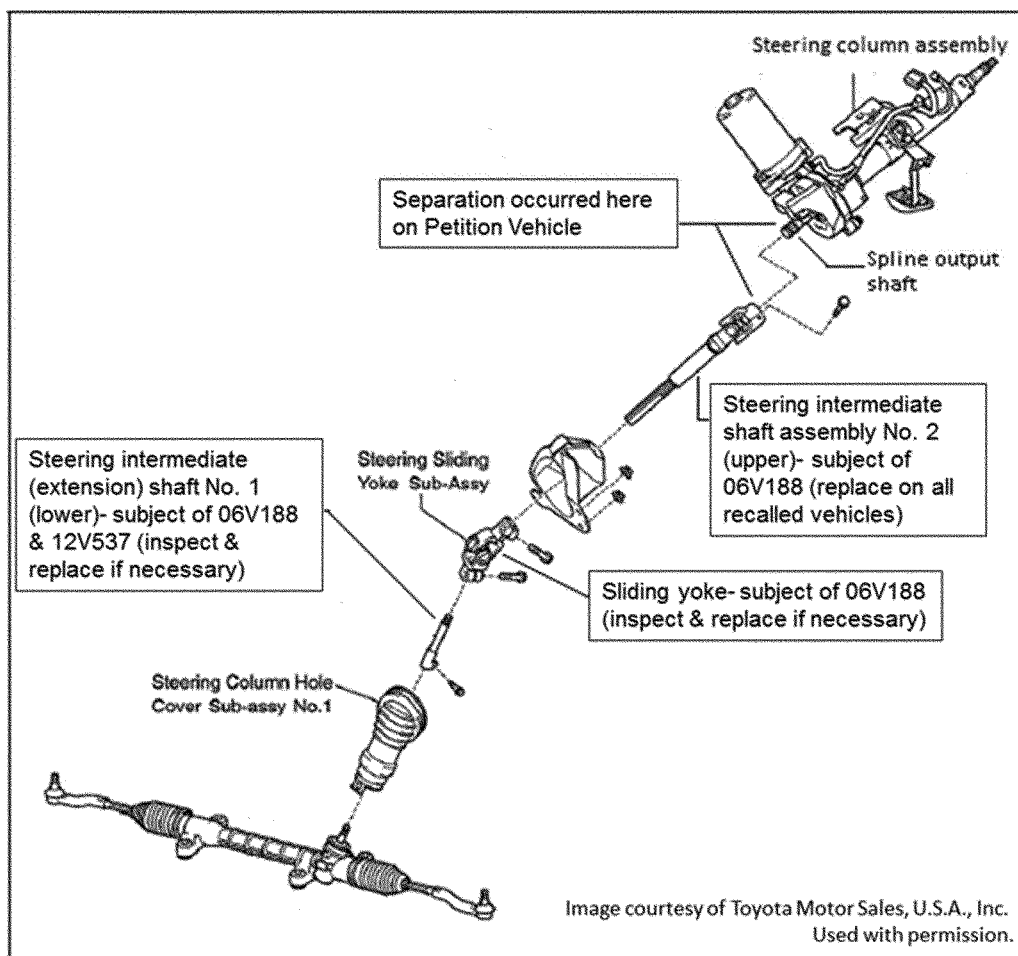
The subject power steering system is assisted by an electric motor linked to the steering column assembly. Steering torque is transmitted to a manual steering rack via a pair of intermediate shafts and a sliding yoke assembly. Image 1 below illustrates the Toyota Prius steering system and the components subjected to the two recalls.
