[Docket No. FAA-2016-0733; Directorate Identifier 2015-SW-040-AD]

#### Airworthiness Directives; Robinson Helicopter Company Helicopters

**ACTION:** Notice of proposed rulemaking (NPRM).

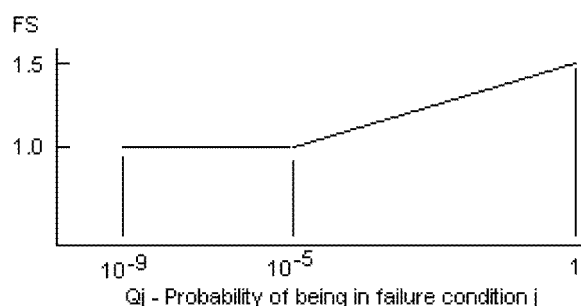
Figure 2: Factor of safety for continuation of flight

$$Q_j = (T_j)(P_j)$$

Where:

$T_j$  = Average time spent in failure condition  $j$  (in hours)

$P_j$  = Probability of occurrence of failure mode  $j$  (per hour)

**Note:** If  $P_j$  is greater than  $10^{-3}$  per flight hour, then a 1.5 factor of safety must be applied to all limit load conditions specified in Subpart C.

establishing  $Q_j$  as the combined probability of being in the dispatched failure condition and the subsequent failure condition for the safety margins in Figure 2 of these special conditions. These limitations must be such that the probability of being in this combined failure state and then subsequently encountering limit load conditions is extremely improbable. No reduction in these safety margins is allowed if the subsequent system failure rate is greater than  $10^{-3}$  per hour.
